NAVAL AVIATION SAFETY CENTER

Reporting Custodian VP-16  
Type of Report AAR Serial No. 1-62  
Date of Occurrence 7-23-62 Acft Model P20-5FS  
Type of Film Coverage MAGNETIC TAPE OF CREW CONVERSATION No. of Reels 2  
TECH. LIB.  
NASC Reel ID No. 11

1	2	3	4	5	6	7	8	9	10	11	12	13	14	15	16	17	18	19	20	21	22	23	24	25	26	27	28	29	30	31	32	33	34	35	36	37	38	39	40	41	42	43	44	45	46	47	48	49	50	51	52	53	54	55	56	57	58	59	60	61	62	63	64	65	66	67	68	69	70
PARTIAL PWR LOSS/FIRE STBD RECIP ENG W/O 4 <sup>th</sup> GCA APPR LOW PASS. AT 250 FT LEVEL FLT PORT PROP FEATHERED. A/C COLL/TREES/GROUND CONTROLLED - BURNED. PILOT FACTOR - FEATHERED PORT PROP VICE STBD.

The primary cause of the accident was personnel error in that the wrong propeller was feathered. This action could have been physically accomplished by either of the pilots or the plane captain.

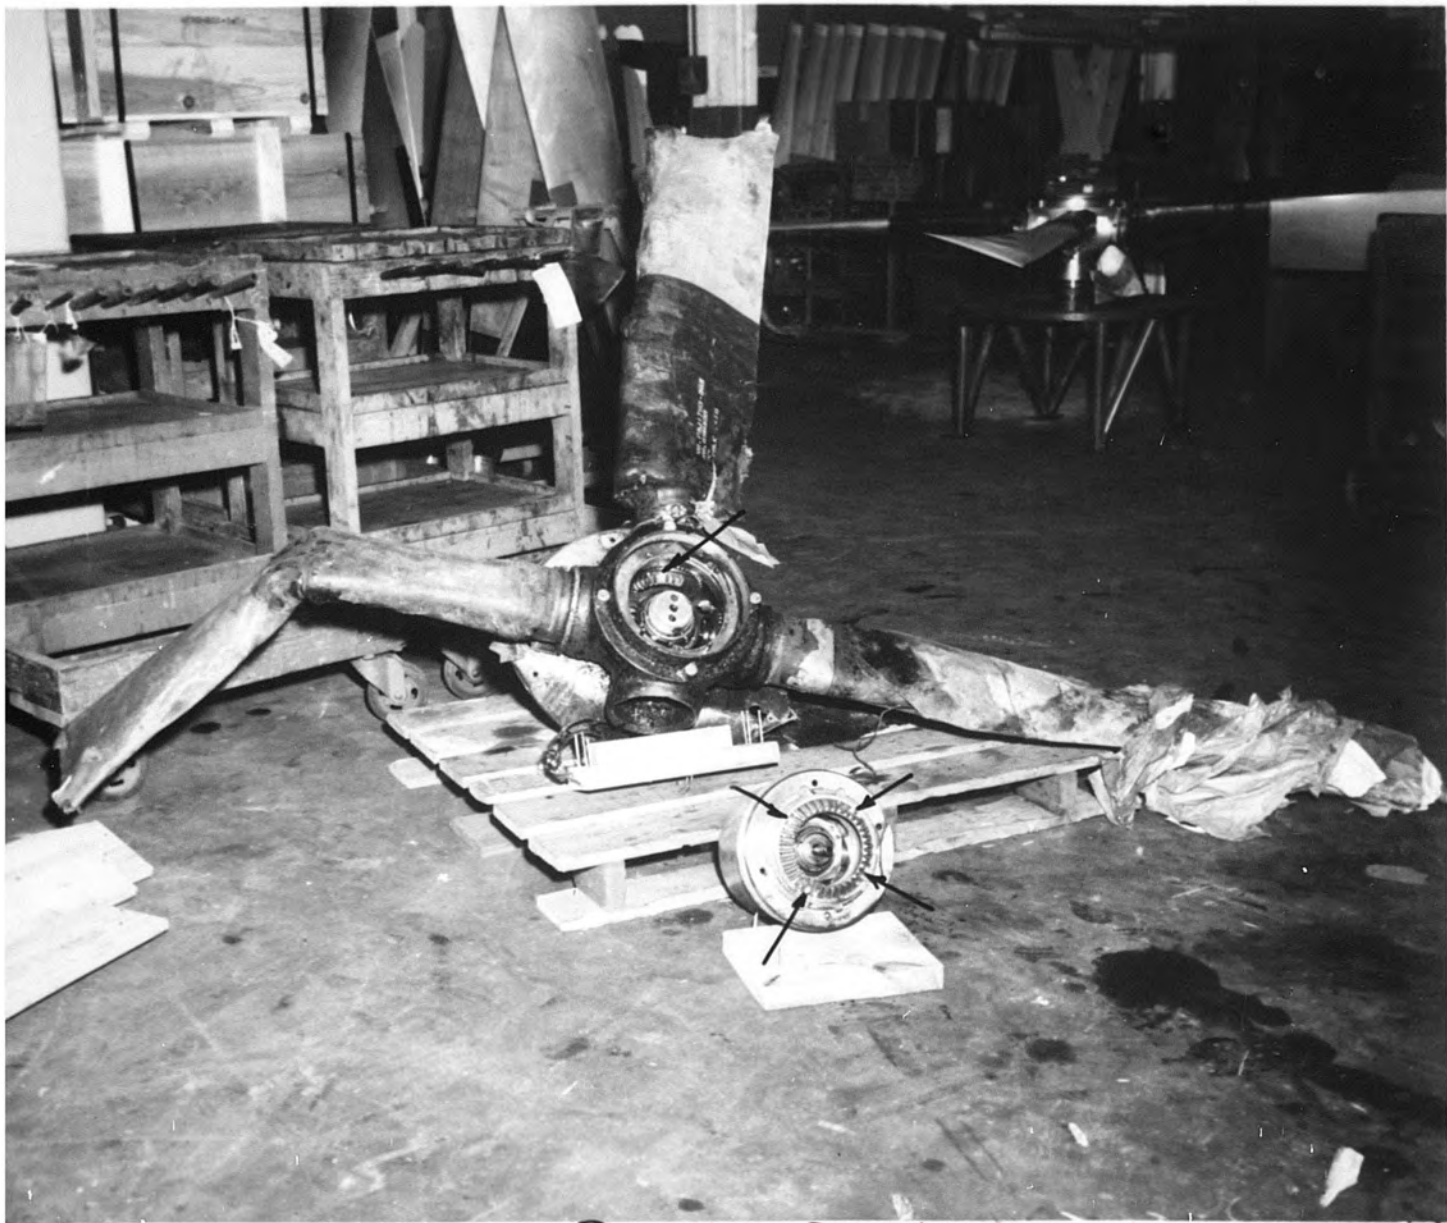
PRIORITY DIR № 98

B. THE NO. 1 BLADE HAD BROKEN APPROXIMATELY TWO FEET OUTBOARD OF THE CUFF.

C. THE NO. 2 BLADE HAD BROKEN AT THE SAME LOCATION AND BENT AFT JUST OUTBOARD OF THE GUFF AS SHOWN.

D. THE NO. 4 BLADE HAD BROKEN AT THE 66 INCH STATION.

F. THE ROTATING CAM GEAR UPON REMOVAL OF THE DOME, WAS FOUND TO BE IN THE LOW PITCH POSITION.

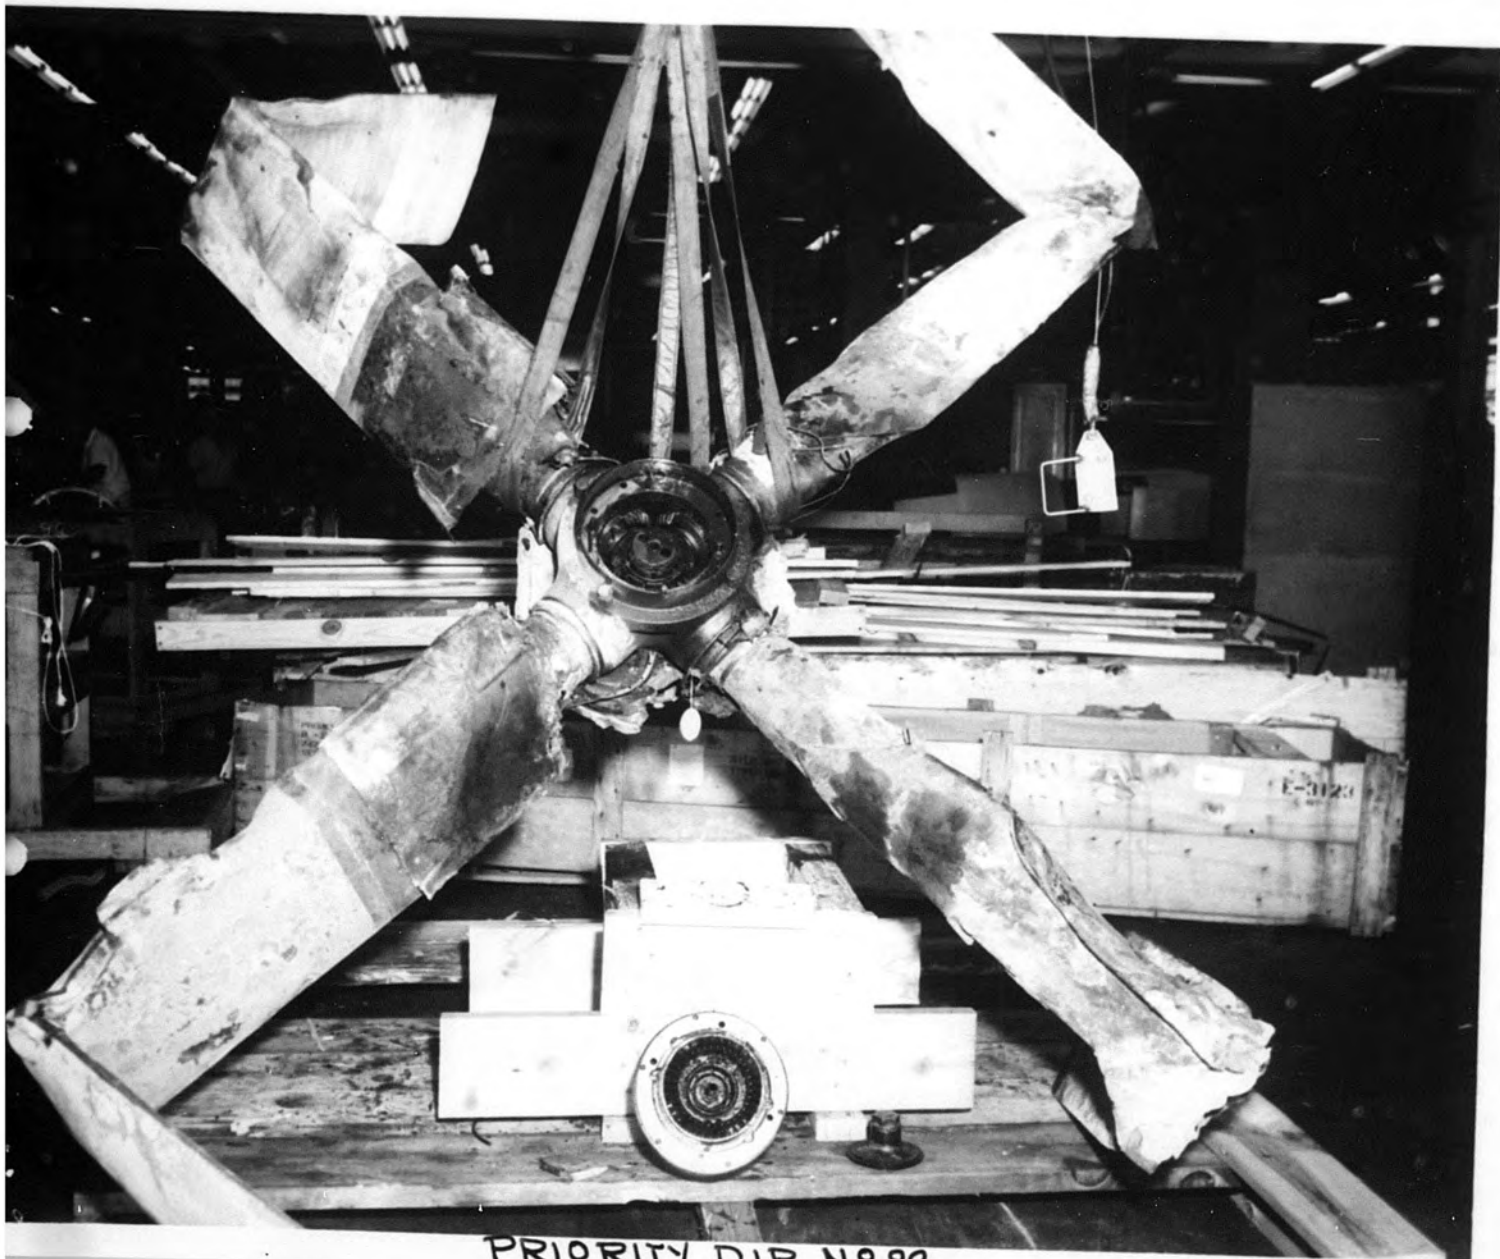
PRIORITY DIR N999

B. BLADE DAMAGE OTHER THAN BENDING WAS CONFINED TO THE LEADING EDGE.

IT IS CONCLUDED THAT THE PROPELLER WAS FULLY FEATHERED AT IMPACT AND DUE TO THE BENDING FOUND ON ALL FOUR BLADES WAS APPARENTLY ROTATING SLIGHTLY.

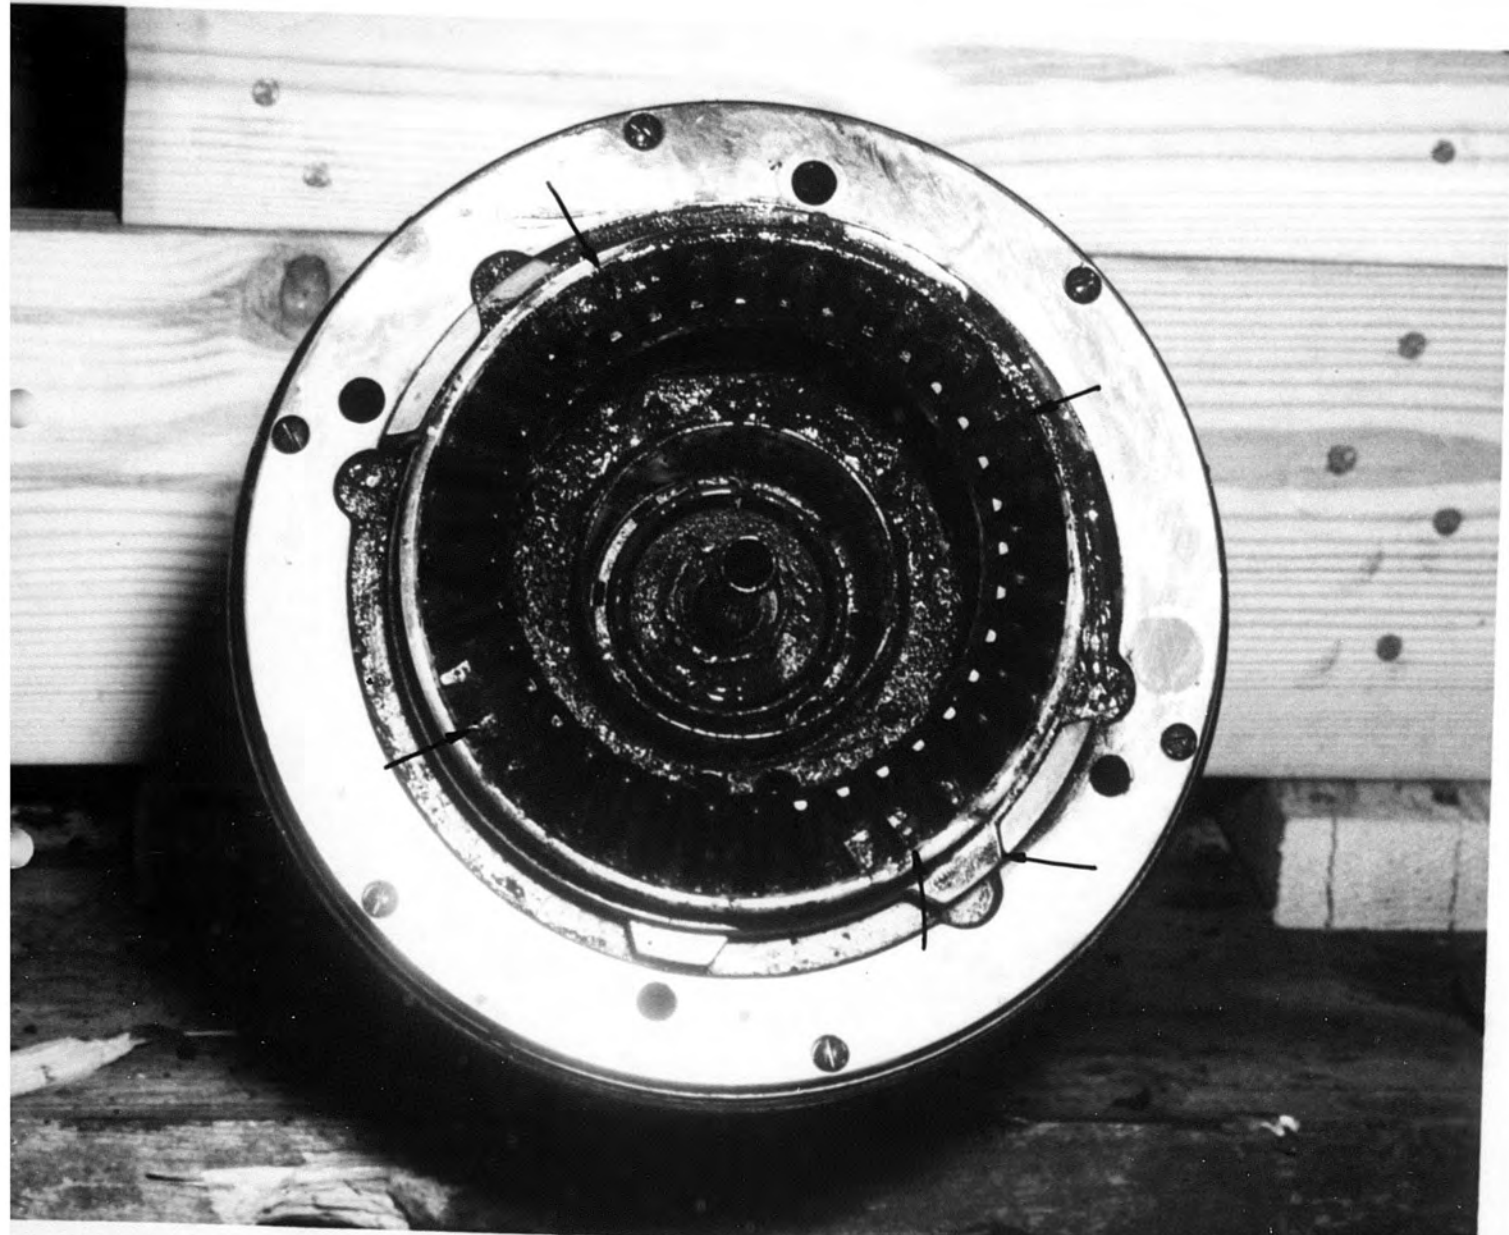
PRIORITY DIR NO 99

C. REMOVAL OF THE DOME ASSEMBLY AND EXAMINATION OF THE ROTATING CAM GEAR DAMAGE INDICATED THE PROPELLER WAS IN FULL FEATHER AT IMPACT, AS SHOWN BY ENCLOSURE (2).

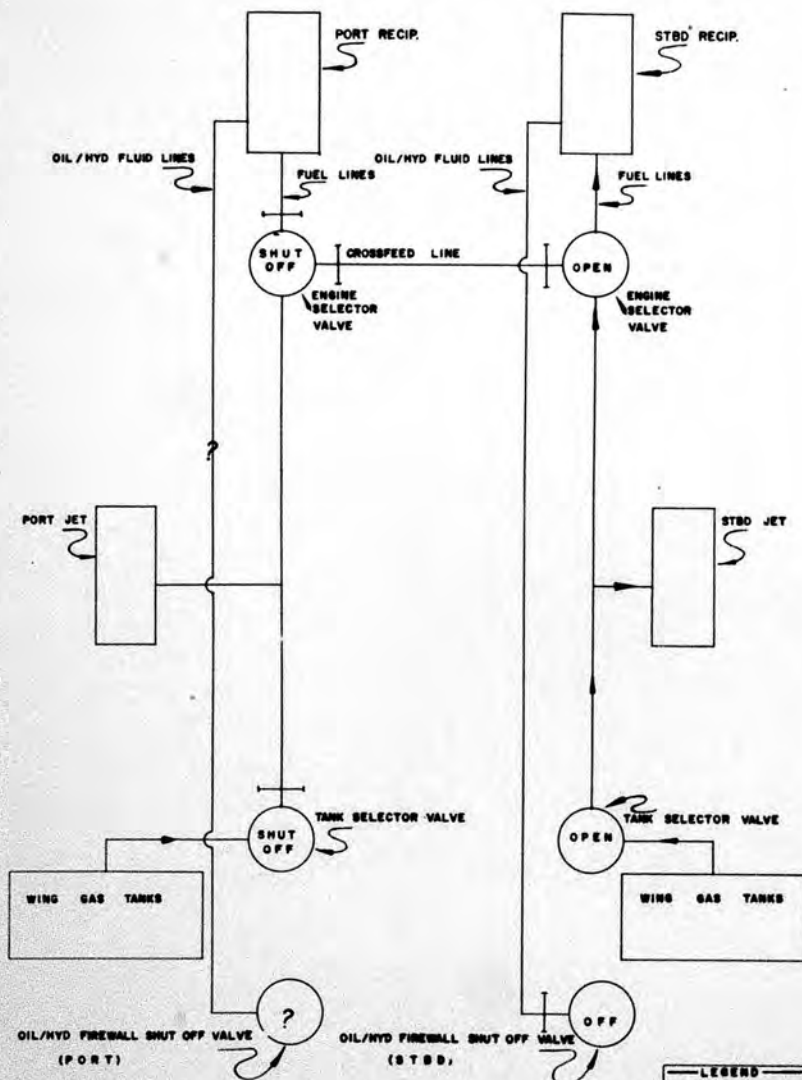
# FUEL SYSTEM SET UP RECONSTRUCTED FROM WRECKAGE

1. The fuel system components found were used to reconstruct the mode of operation of the fuel system at the time of crash as illustrated in enclosure 9. Positions of valves illustrated in enclosures 8 and 9, were determined from examination of the valves except in the case of the port side engine selector valve. In this case it was determined that the valve was shutting off the fuel to the port reciprocating engine from the position of the chain end relative to the gear on the fuel panel stem. Starboard oil and hydraulic firewall shut off valves were in the shut off position as illustrated by enclosure 10.

jet to be operating at a speed somewhere between idle and normal at impact, as indicated by the DIR, this valve must have been closed immediately prior to impact or as a result of impact. The same conclusion is made for the oil and hydraulic firewall shut off valve to the starboard reciprocating engine (enclosure 10) since the preliminary DIR reveals no evidence of oil starvation in this engine and it was in fact developing some power on impact. The unusual fuel system mode of operation found after the crash has therefore been determined to have been a result of either a last minute preparation for the crash or a result of impact. There are no indications of fuel panel mismanagement.

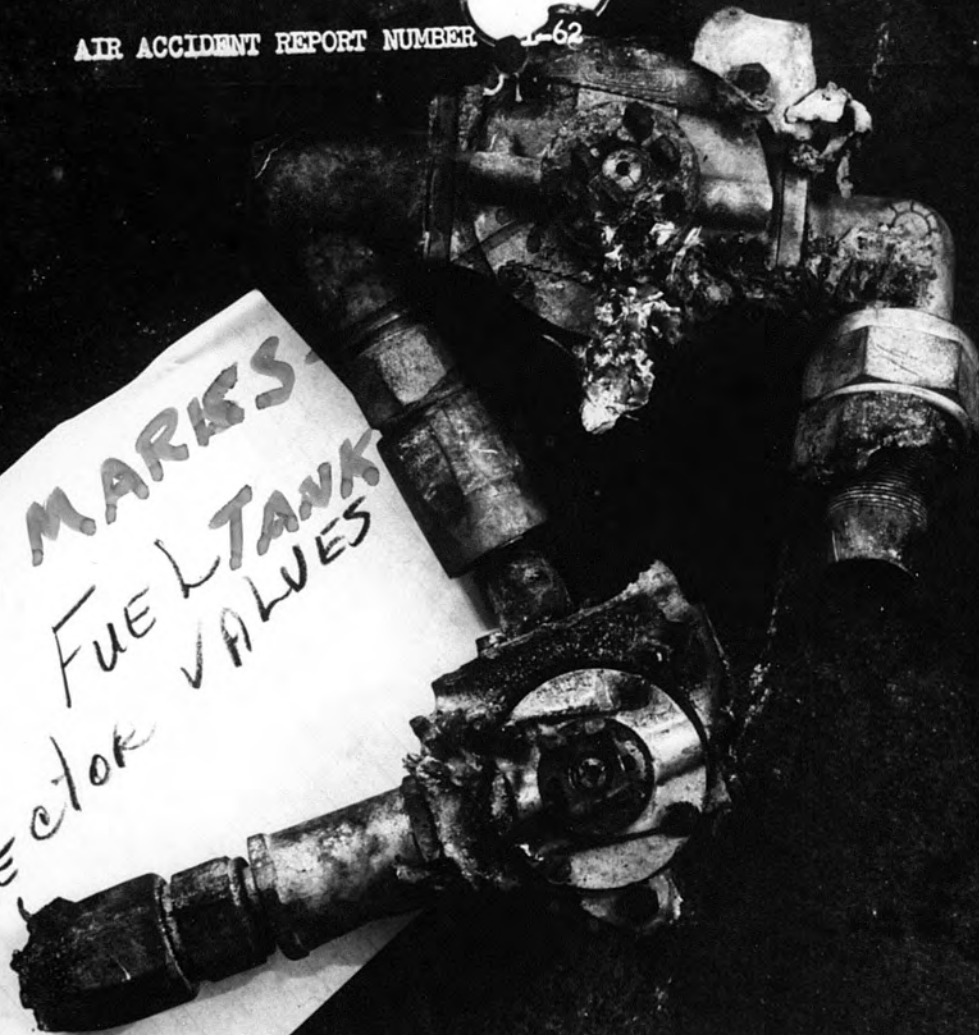
FLOW MARKS  
Port FUEL TANK  
Selector VALVES

The port fuel tank selector valve was found in the closed position, thus denying a source of fuel for the port jet. In order for the port

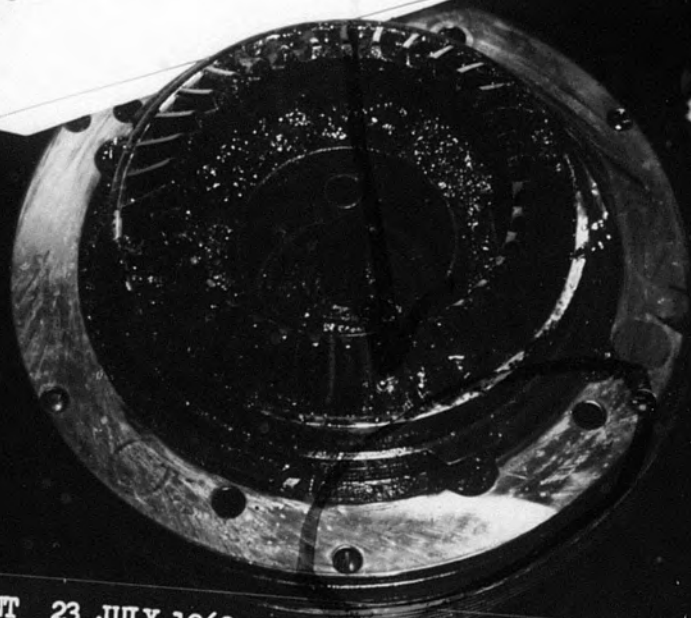
Port ENGINE  
Prop Dome

FULL FEATHER
